DL4000 VIDEO TRANSPORT SYSTEM MODULE

DLC300 Quick Start Guide

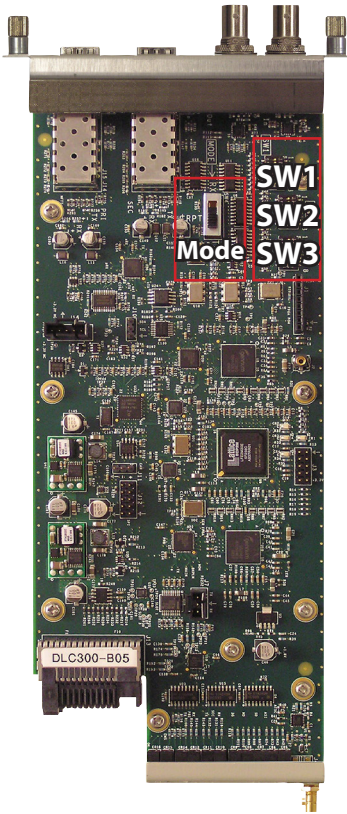
Artel ships the DLC300 configured as follows:

- Transmitter mode selected
- All signal types allowed
- Electrical input set to BNC
- Standby signal set to Artel non-video standby signal
- SDI Standby set to 525 line (SD-SDI), 59.94 fps (HD/3G)
- Forced bypass is disabled (when forced bypass is enabled, all signal classification, processing, and relocking is bypassed)
- SDI processing set to No EG34 dithering
- ATSC to ASI conversion is disabled
- SFP alarms are enabled
- Optical reversion is disabled
- Video loss alarm is disabled
- EMS override is enabled (DL Manager can change the DLC300 configuration)
